# Richard Johnson Law Office

Clinton, Georgia

## A Historic Structure Report

Prepared by:  
Olivia Head  
Ross Sheppard

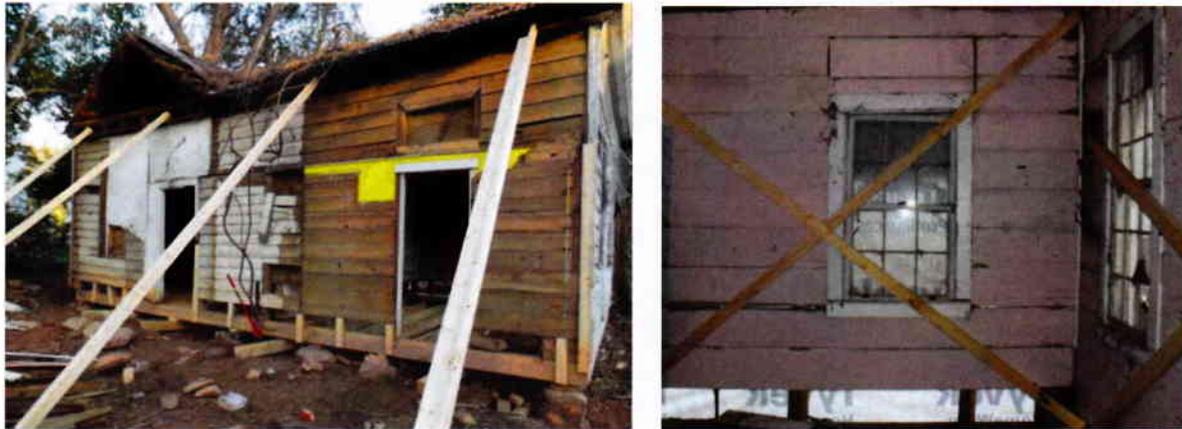
the remaining wood lathe, through which cut nails have pierced, visible from inside the attic. Additionally, several of the windows were replaced with shorter windows as evidenced by a larger opening outlined above the shorter windows now filled with shiplap.

*These photos display changes that have occurred throughout the building's history. Above left: The porch has been removed in this photo, but is evidenced by the unpainted siding. The added gable is still present in this photograph by the Old Clinton Historical Society. Above right: The original opening appears larger than the current window, and the window to the right is taller than the current window.*

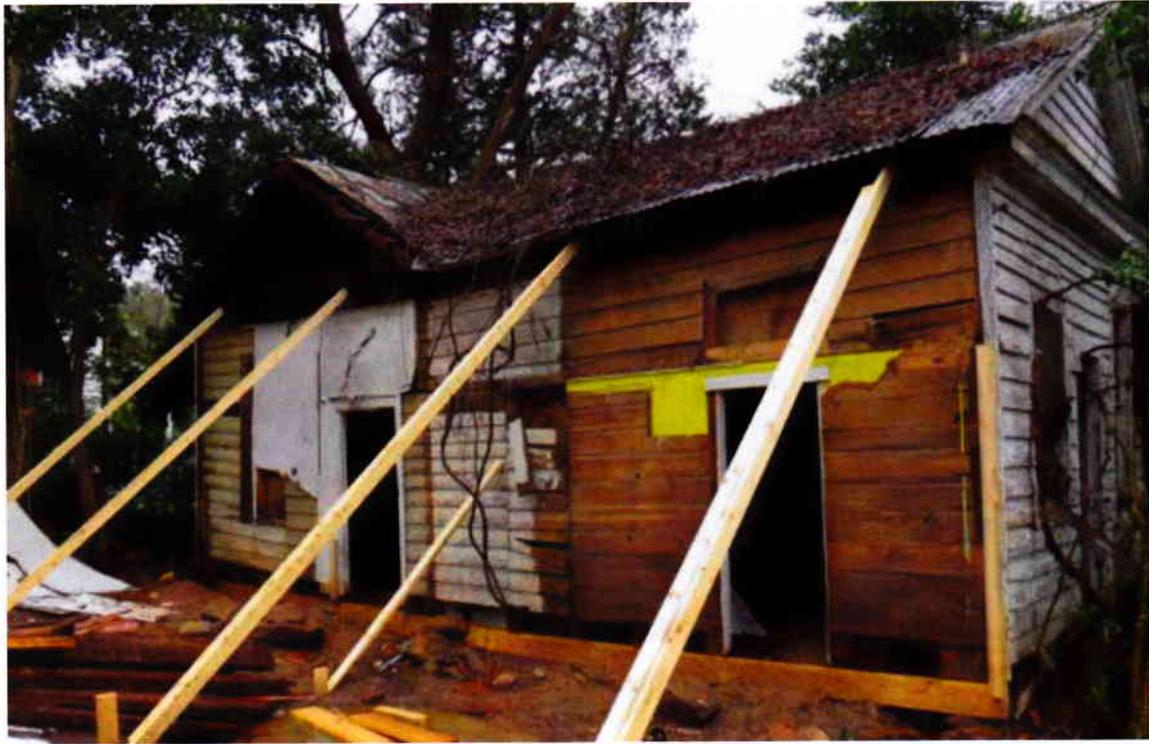
*Above: North facade of the building, originally the west. Note the added gable has now been removed. Photograph by OCHS.*

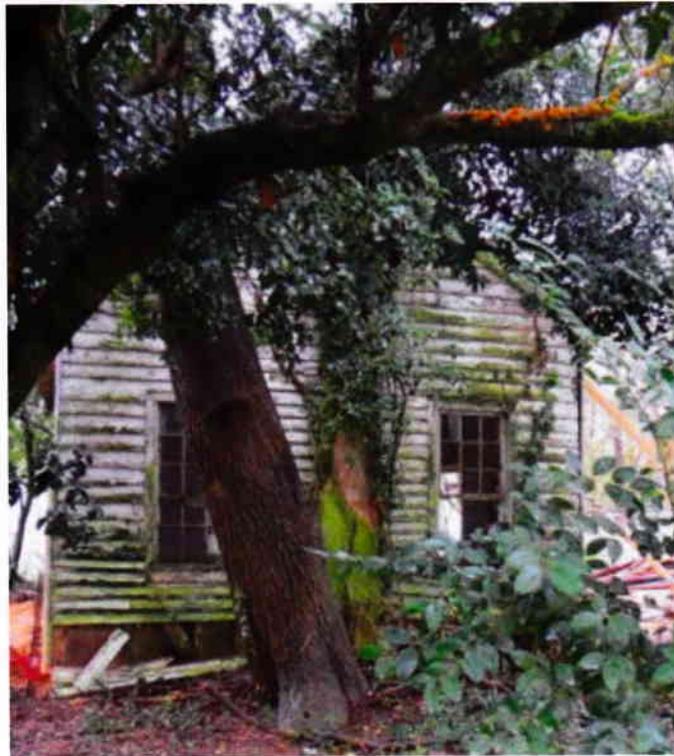
*Above: East facade of the building, originally the north. Note the ghost of a chimney. Photograph by OCHS.*

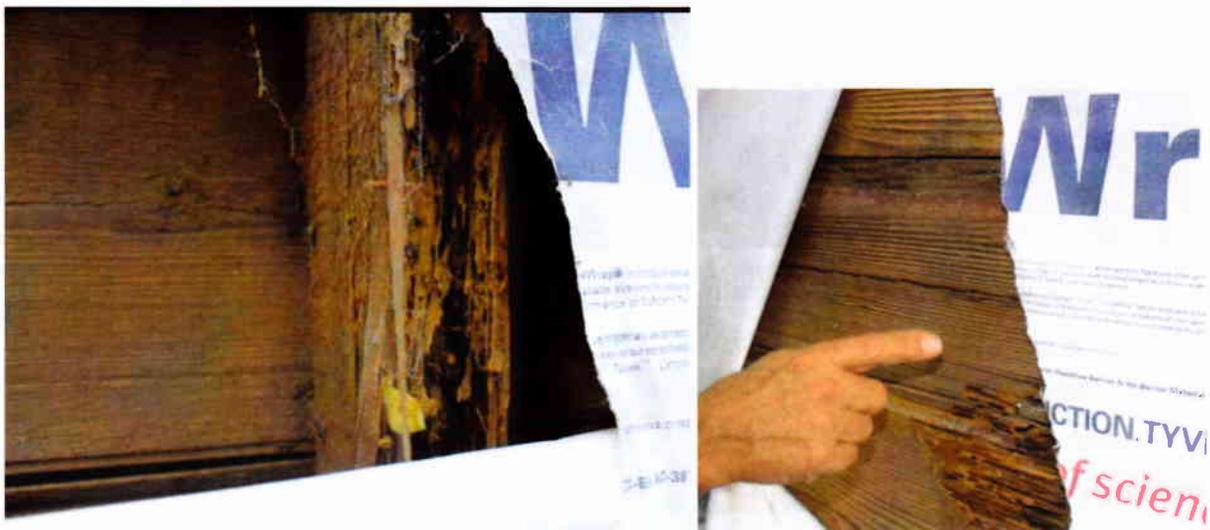
The most significant issue with the exterior and interior of the law office is termite damage. Termites accessed the flooring system and the studs when the building was turned and inadequate foundation was provided. Termite damage is apparent in several of the studs and the exterior siding. There is, however, no active termite infestation. Additional insect damage was inflicted on the building by powder post beetles, which does not necessarily affect the structural integrity of the building but does affect the aesthetics. Much of these damaged parts have already been cut away, and 2x4s and other modern lumber have replaced the worst of the termite damage; however, replacement of additional structural members may be needed.

*Above: Termite damage deteriorating one of the studs and damaging some exterior siding. Unfortunately, this is a relatively ubiquitous problem for the law office.*

Although we observed much structural damage from termite infestation and other moisture or mechanical issues in the lower portion of the building, our visual observation was restricted to that lower portion and therefore limited. Thus, there may be additional termite damage to certain members making further repair, sistering, or replacement necessary. We suggest replacing with harvested historic heart of pine or other old growth wood appropriate for the period of significance.

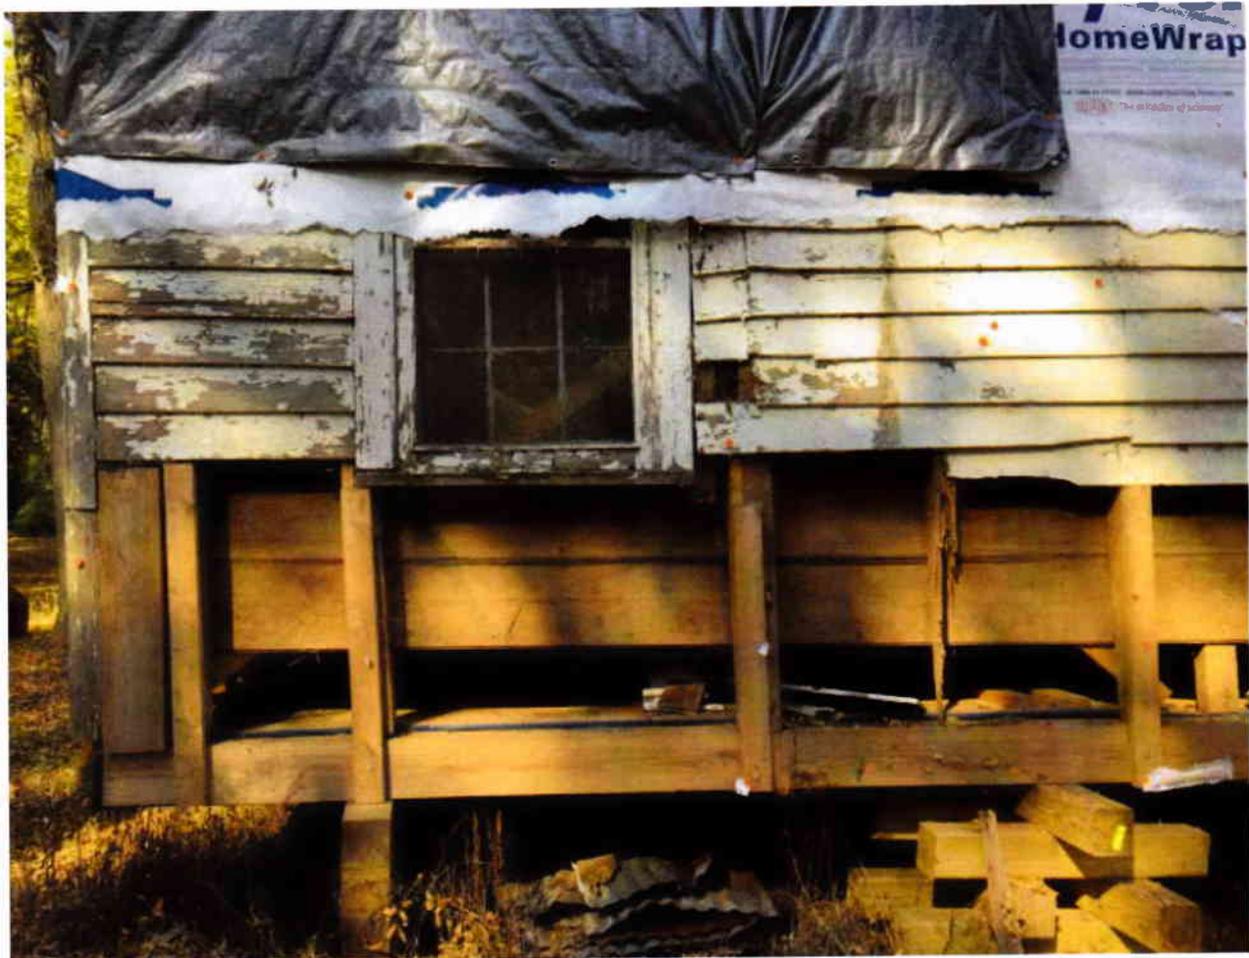
A significant portion of the exterior clapboard siding was removed during the stabilization of the move as the floor system was completely replaced. While there are certainly clapboards that should be replaced, many of them can be salvaged. Those that can be salvaged are currently suffering from chipping paint.

*Above: A significant amount of clapboard siding was removed for stabilization, and some of the siding that remains is suffering from chipping paint.*

Because the exterior and interior siding is somewhat fragile, we suggest hand scraping the chipping paint off and repainting where necessary. Chemical treatments should not be necessary.

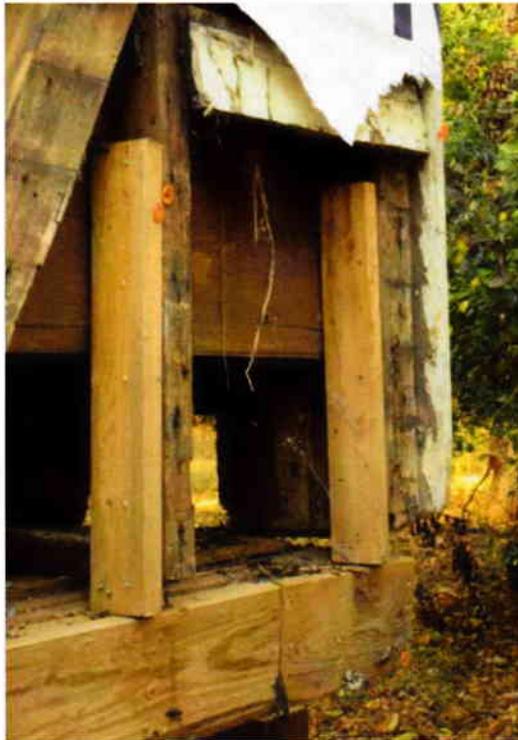
With the replacement of the floor system, the original joists were removed and disconnected from the studs. Most of the studs are not themselves currently tied into the sill. Instead, all of the studs and one of the braces have new 2x4s attaching them to the sill, extending upward from the sill just beyond each member's compromised material. Because these 2x4s do not extend the full height of the studs, they cannot be considered true sisters. It appears that the structural members still covered by the intact clapboard siding have not failed and are not compromised, but some additional sistering, or replacement, of structural members may be needed.

*Above: Example of original studs and corner post not extending to replacement sill with sister extending instead.*

Further stabilization will be necessary. This will consist of replacing the existing temporary bracing with sisters that span the length of the studs. The studs and sisters will need to be tied back into the sill plate with an appropriate connector, such as a Simpson Strong-Tie product. Knee walls should be constructed under window sills as needed to provide support.

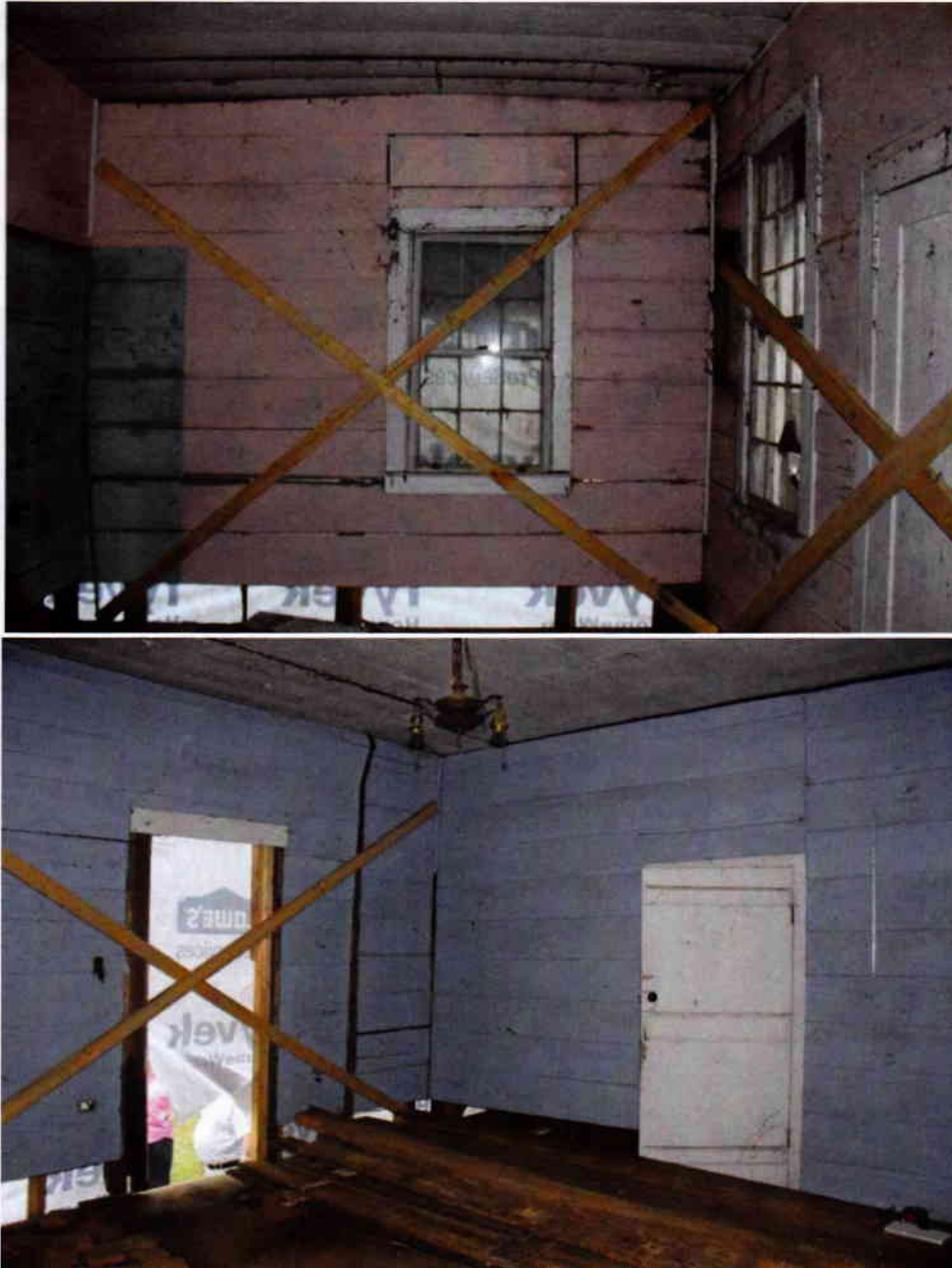
The interior walls are clad with shiplap siding, which is mostly in decent repair. Although the paint colors are currently pink and blue, it is covered by several layers of paint, some of which is chipping. The ceiling is clad in white-painted shiplap. A majority of the interior cladding is covered in surface debris, which will need to be cleaned in the restoration. Additionally, some of the shiplap is buckling and separating from the wall studs.

*Above: These photographs display the pink, blue, and white shiplap that clads the interior of the building. Debris is especially evident in the picture on the left. The photograph on the right shows some of the shiplap buckling in the corner.*

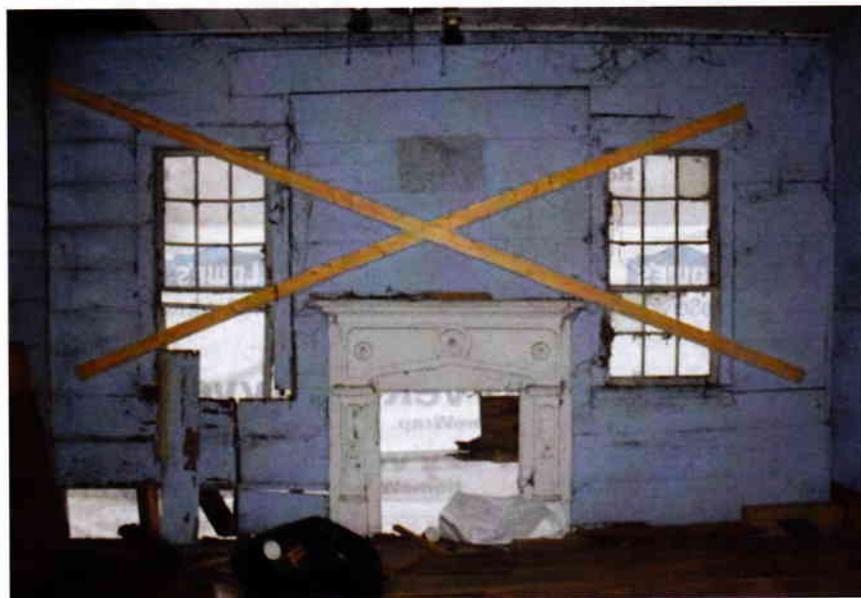
room has a nonfunctional lighting fixture suggesting that the building has previously been electrically wired, but we cannot be sure without further investigation whether or not this wiring is current.

*Above: The window on the left has a missing sash and stool and a casing that would not reach the stool. Notice also the mantelpiece and missing fireplace and chimney. Also note the non-functional lighting fixture.*

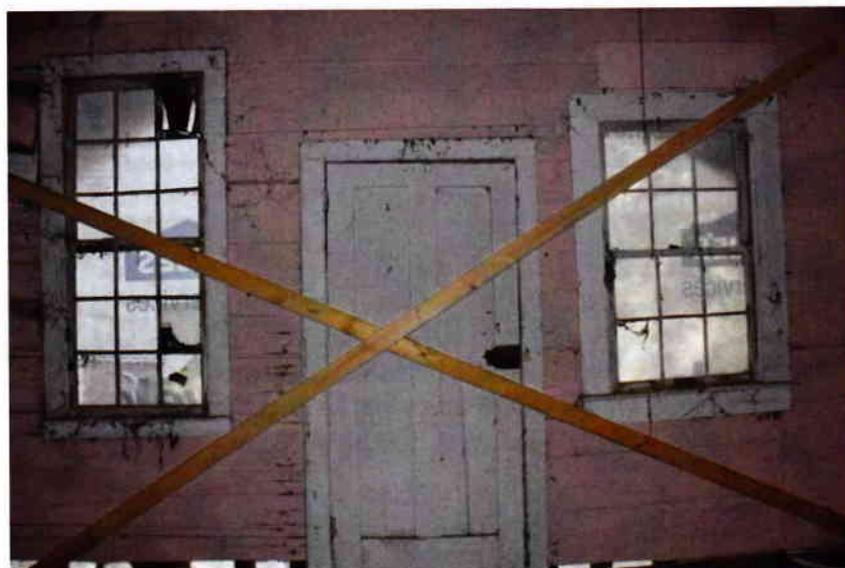
*Above: The nine-over-nine window, which fits the original opening is missing one full pane with parts of others missing.*

The historic windows on the now western facade and now eastern facade that are 9 over 9 double hung sash and 9 over 6 double hung sash should be replaced. We recommend contacting Taylor Davis of Low Country Preservation in Brunswick, Georgia who specializes in repairing and replicating historic windows. From photographs, he has confirmed that at least the 9 over 9 window on the western facade can be repaired. Taylor’s email address is [taylor@lowcountrypreservation.com](mailto:taylor@lowcountrypreservation.com), and Low Country Preservation can be reached at (912) 230-1260 or (404) 259-7655.

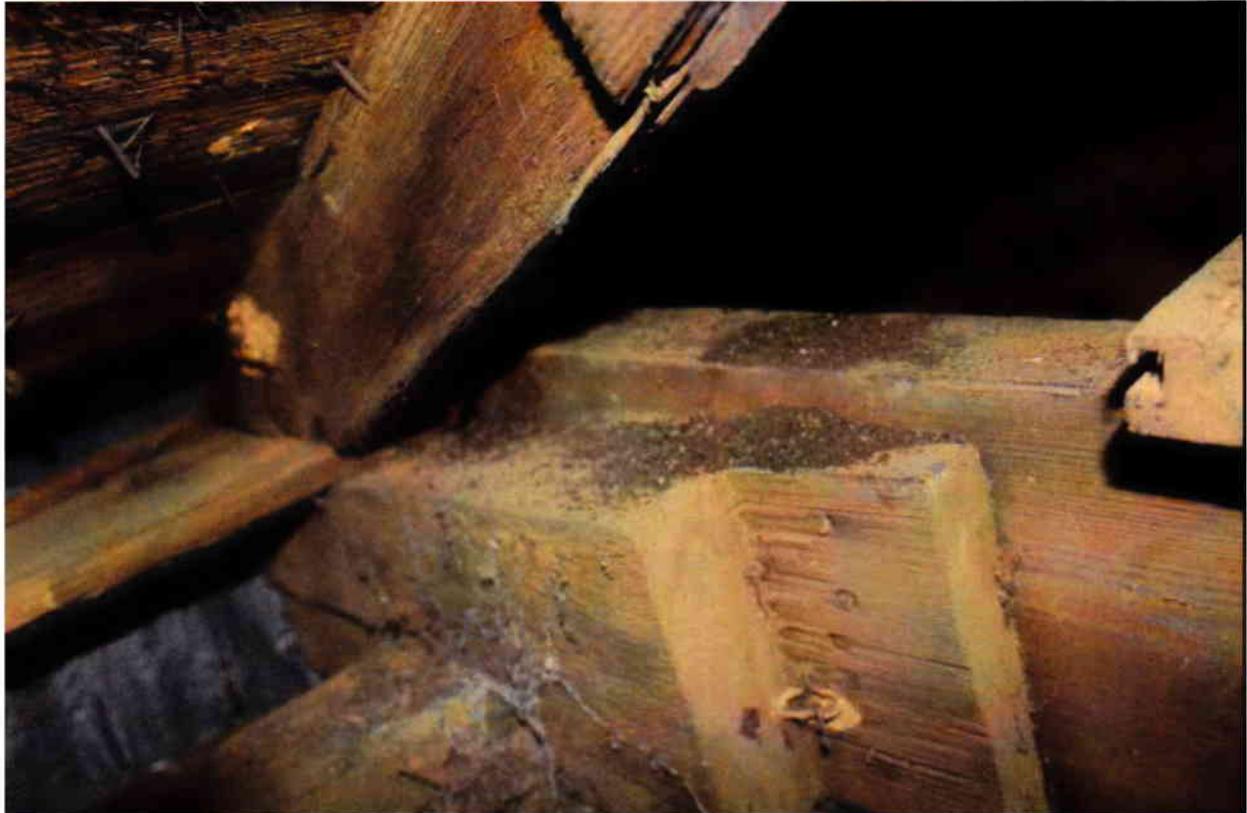
The roofing system is a common rafter system where the rafters rest on a false plate. There are no collar ties, purlins, or a ridge board. Wood lathe pierced by nails, which remain in place, suggests the original use of wood shingles. It appears that the ceiling joists have been sistered at the end, but it is not clear from observation why this was done.

*Above: This photograph shows the cut nails protruding through the wood lathe, indicating that wood shingles were the original roofing material and that those shingles were simply ripped off when replaced. This also shows the sister at the end of the ceiling joist that is currently supporting the false plate.*

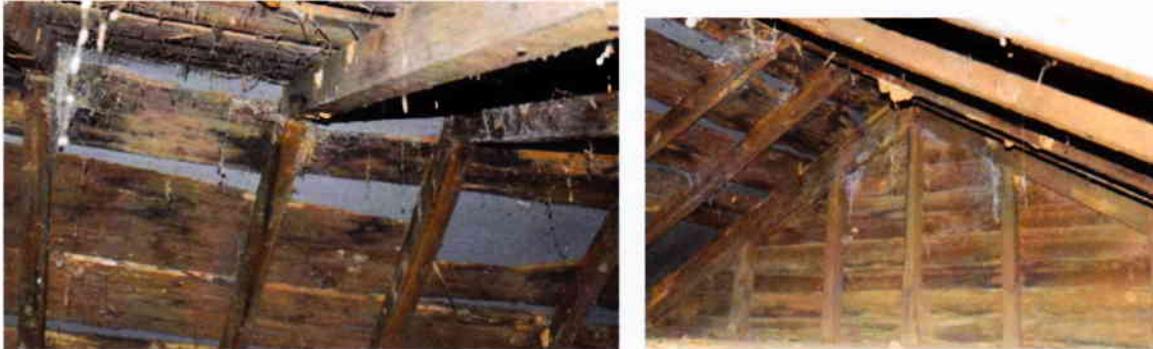
Although a good amount of the wood lathe for the roof cladding is intact, some of it is missing or deteriorated. The wood lathe that is intact is spaced. Spaced wood lathe was typical for wood shingle roofing as the wood had to be able to breathe.

*Above: These photographs reveal missing or deteriorated spaced lathe that will need to be replaced.*

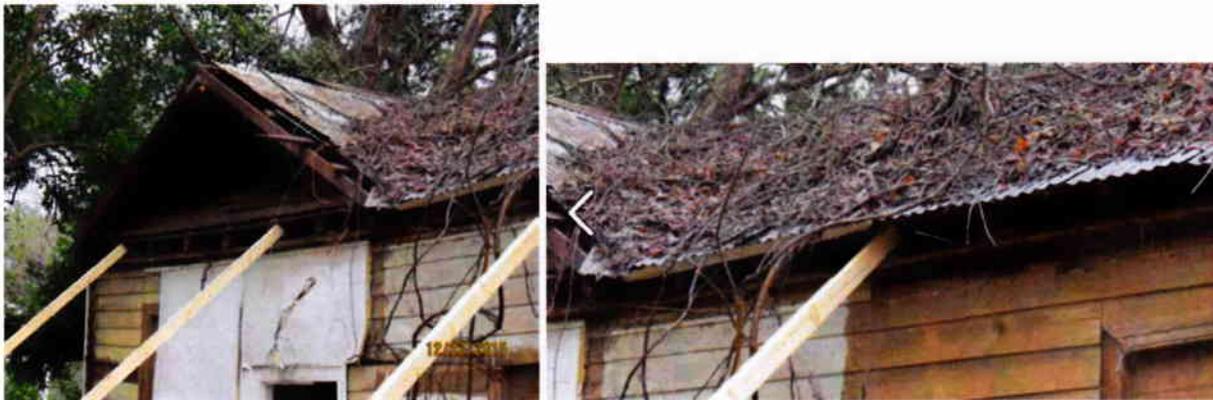
The metal roof cladding was removed from the roof structure before the move leaving the wood lathe exposed. Therefore, the exterior roofing elements are currently covered in Tyvek to protect the uncovered wood lathe and rafters from further water damage. However, photographs taken by the OCHS indicate that the fascia has been removed on the rear facade of the building.

*Above: These photographs reveal the lack of fascia on the north facade.*

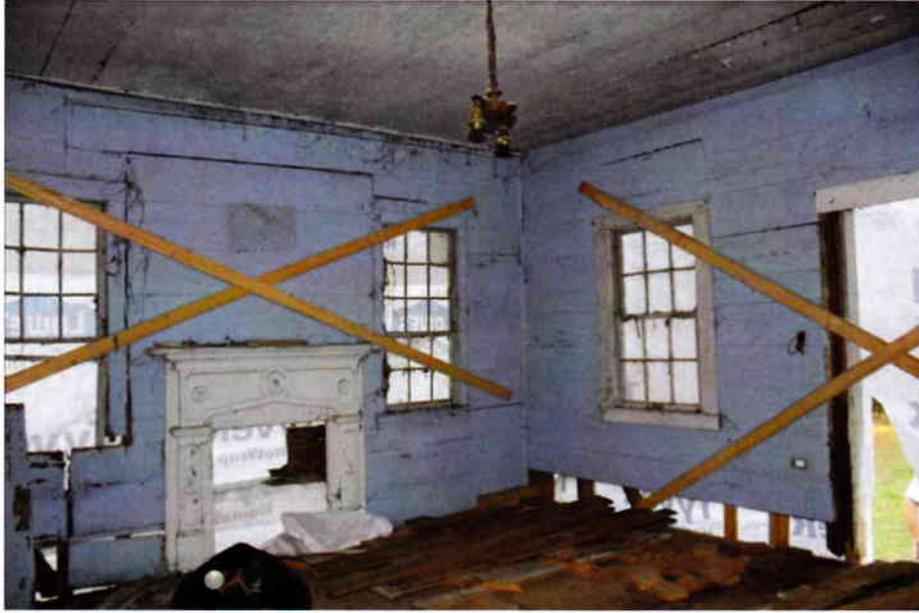
The lack of modern plumbing and electrical system coupled with a lack of demand, the building will not retain its historic use. Instead, because the building is owned and managed by the Old Clinton Historical Society, it should be converted into a museum of Old Clinton history. This use will honor its historic function and provide a new educational and architectural attraction for visitors of Clinton. Materials that cannot be repaired and therefore have been removed from the building, especially if they convey the craftsmanship techniques of the period of significance, should be salvaged for display in the museum. Additionally, this conversion will require some electrical updating to provide for lighting, which has been added previously as evidenced by a lighting fixture hanging in the blue room but is no longer functional.

*Above: Note the lighting fixture, light switch, and place for an electrical outlet indicative of some time of electrical wiring.*

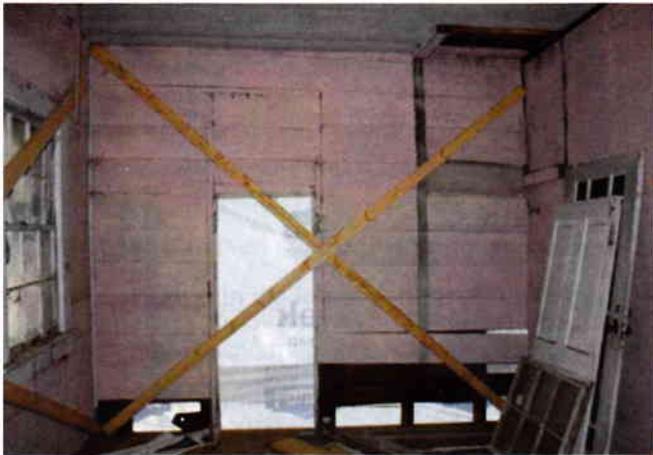
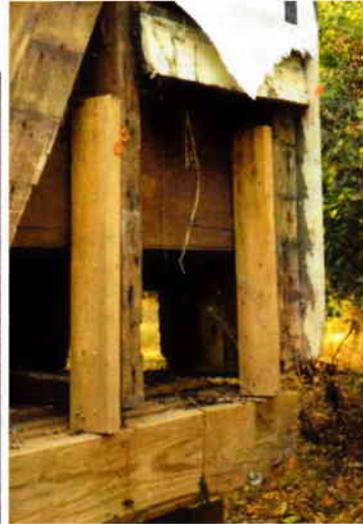
*Above: Interior bracing and partial sisters that comprise current stabilization.*

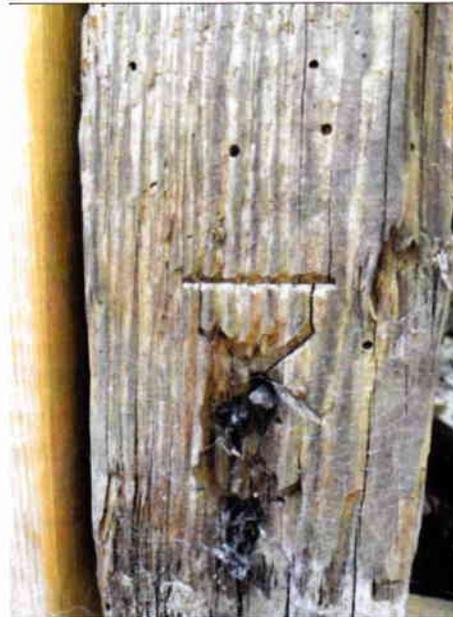
*Above: Roman numerals are noticed on many of the larger framing members. This is common of timber-framed, or brace-framed, construction.*

Although they will be covered up by the exterior and interior cladding, the Roman numerals carved into several of the studs should be preserved and documented. These carpenter marks were often carved into rafters or mortise-and-tenon joints to ensure that the correct structural members were connected to each other. They therefore represent craftsmanship indicative of the early nineteenth century. If any of the studs containing these carpenter numerals are found to be irreparable, they should be salvaged for display inside of the law office.
